Case study of suspected moldy metal kitchenware

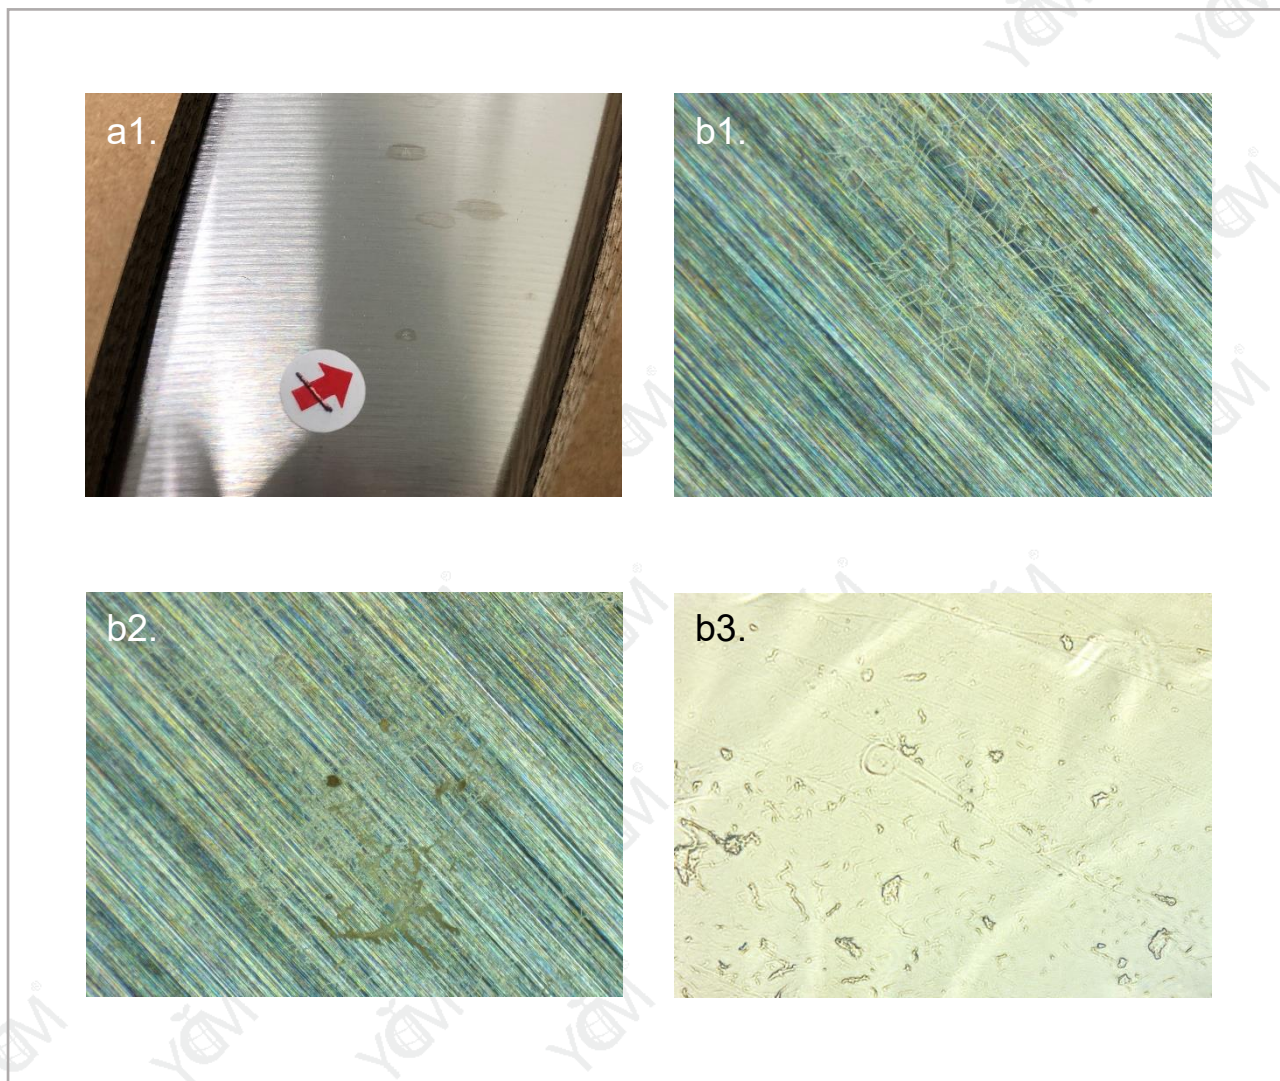
Fig 1. Metal products sent by Brand S for Inspection

The metal knives submitted by Brand S showed visible spotted contamination. After being tested by

YCM MRC, no mold growth structures were found (Figure 1).

a1. Suspected moldy metal kitchenware from Brand S ; b1 - b3. Metal products from brand S were observed under a microscope at different magnifications, and no mold growth structures were found.

After being tested by YCM MRC, it was determined that the spotted contamination on the knives of Brand S was not caused by mold. Although the filamentous structures on the spotted contamination may resemble mold in appearance, a detailed analysis of their morphology and material characteristics can accurately distinguish the two. While mold growth and filamentous structures have different causes, with the former occurring under suitable conditions of temperature, humidity, and nutrients, and the latter resulting from moisture

intrusion, both have a significantly increased probability of occurrence in humid environments. Therefore, regardless of the cause of product damage, environmental control is a fundamental and crucial aspect of preventing such harm.

Through this collaboration with Brand S, not only was the source of contamination identified, but also dual preventive measures for mold prevention and corrosion prevention were provided, assisting in product quality control, and reducing losses in costs.
